TECHNICAL REPORT 2020 UPDATE

ON THE PAJARITO GOLD / SILVER PROPERTY, MORELOS MUNICIPALITY, CHIHUAHUA, MEXICO

April 13, 2020

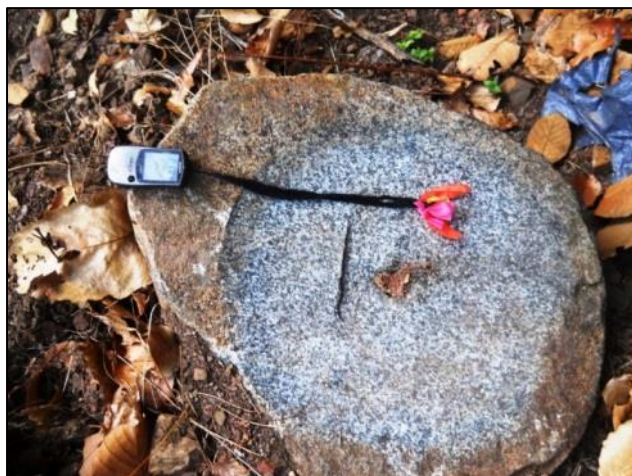
Figure 18. Millstone for Hand Grinding

There is only oral history of the Pajarito Project area and early ownership refers only to someone's grandfather mining a deposit. According to that history, production of gold from high grade (reportedly about 12 ppm) veins in the area occurred in three primary areas from the 1800s until the 1930s. Scattered primitive grinding stones (Figure 18) support that production was for free-milling gold.

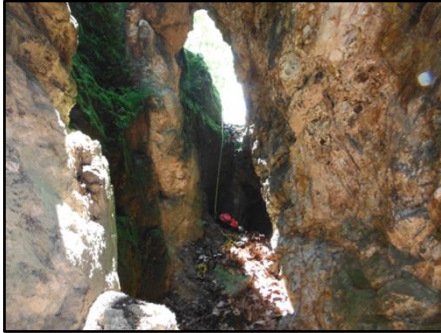
Figure 40. Pajarito Mine.

The Pajarito mine is a small scale historical mine which produced from a narrow shear-vein (Figure 40). Two holes were drilled in 2016 to test the vein. The best intersection was 1.3 m. @ 1.85 ppm Au. Additional mapping and sampling in 2019 showed previously unsuspected gold mineralization in sandstone beds (Figure 41). Visual cues to mineralization were silicification and iron oxides. The sandstone target has never been explored.

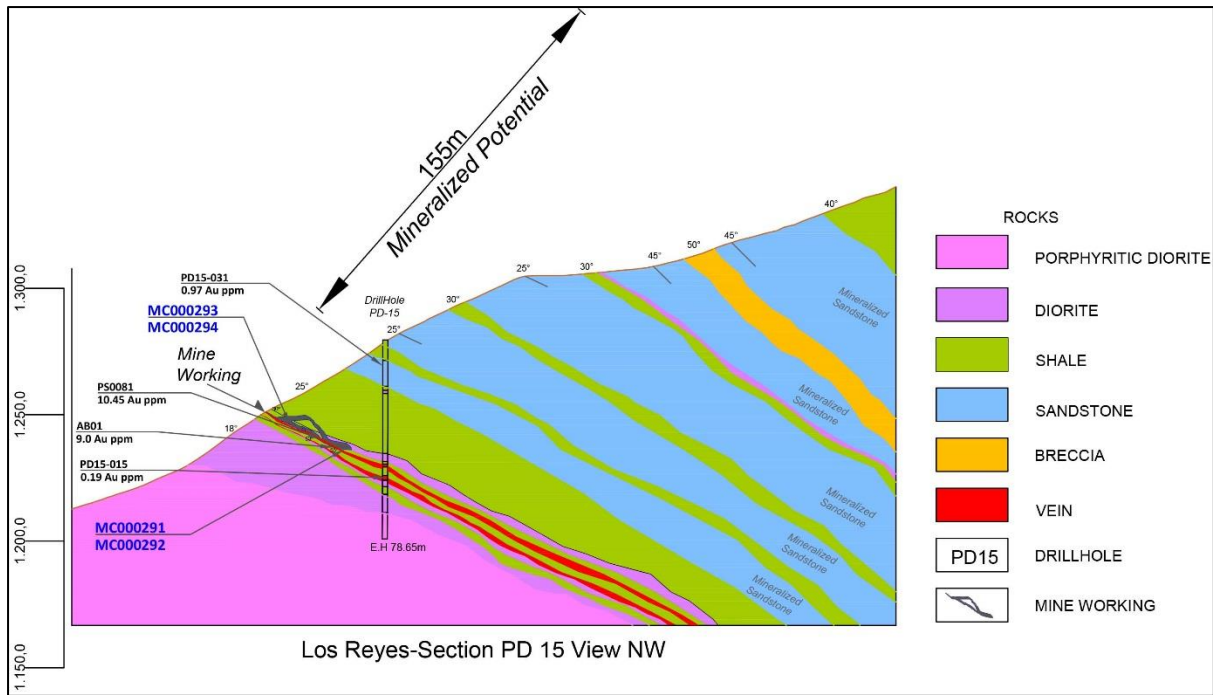
Figure 45. Los Reyes Mine Geological Section.

A measured section of the Reyes hillside shows how much additional potential is added when sandstones and breccias are considered as potential hosts of more subtle mineralization (Figure 45).

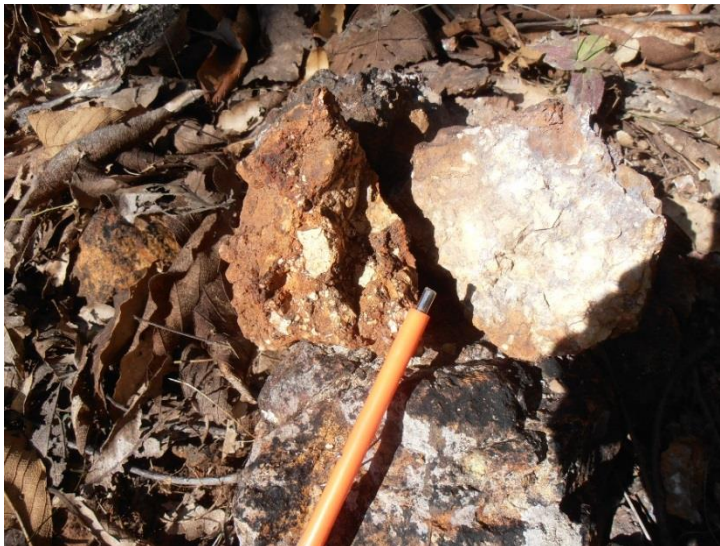
Figure 46. Santa Rosa Breccia.

The structurally controlled Santa Rosa breccia (Figure 46) is about 350m long and mainly oriented NNW changing to NE at one end. It is generally medium gray, tan to reddish brown color, and consists of 40 to 80 % subangular clasts of quartz veins, sediments and minor diorite with weak to strong silicification. The matrix is weakly silicified rock flour with specularite and hematite. There is little to no clast rotation. This structure is cross-cut by a road exposing a breccia with significant alunite / kaolin alteration (Figure 47).

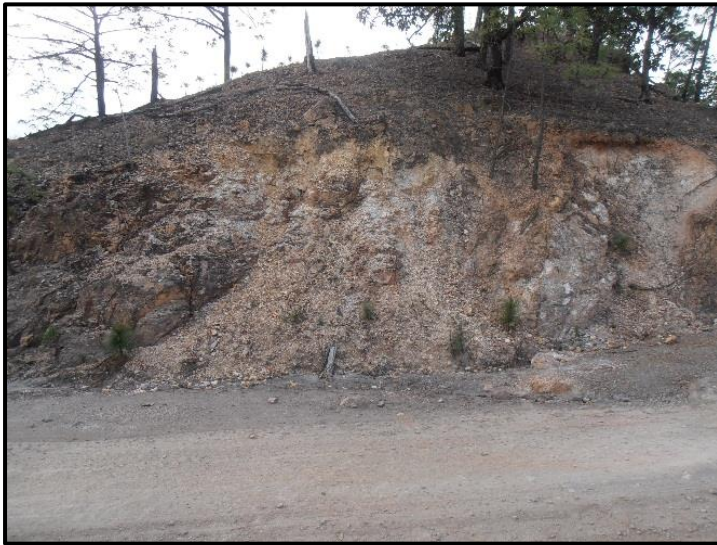
Figure 47. Road Cut.

to the southern contact with a discontinuous weak to locally strongly silicified halo cut by quartz-specularite stringers at contact with sediments. Four (4) samples have been collected during preliminary reconnaissance of this target with Au results up to 5 ppm.

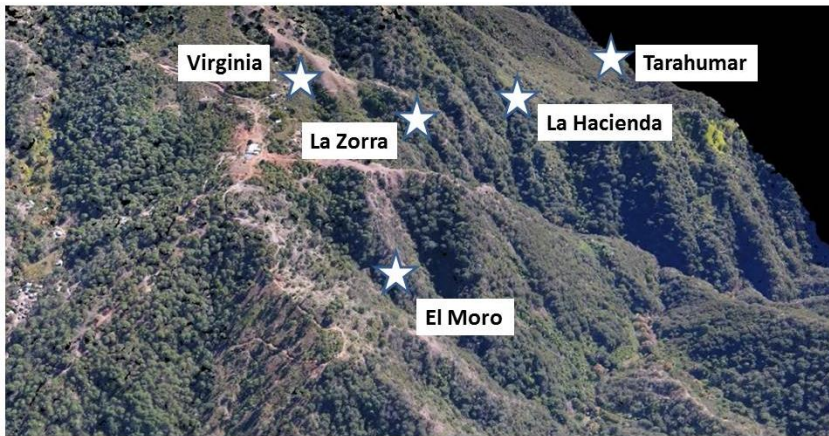
Figure 49. Drone Photo of Mineral System.

A drone photo best shows most clearly that all are part of one mineral system (Figure 49) where there is mineralization wherever there is porosity and permeability, whether from structures, sandstones or a hydrothermal breccia.

There now is enough information to consider the MVZ area as one mineral system where mineralization can occur whenever there is porosity and permeability caused by shearing, sandstones or hydrothermal brecciation. Mineralogy suggests the system is centered at the La Zorra mine which is situated over a warp in the total field magnetic survey that may represent the causative intrusive. There are nearby prospects south of La Zorra where sampling during a rapid recon pass showed gold mineralization. The proximity of the gold deposits suggests they may be part of the same mineral system.

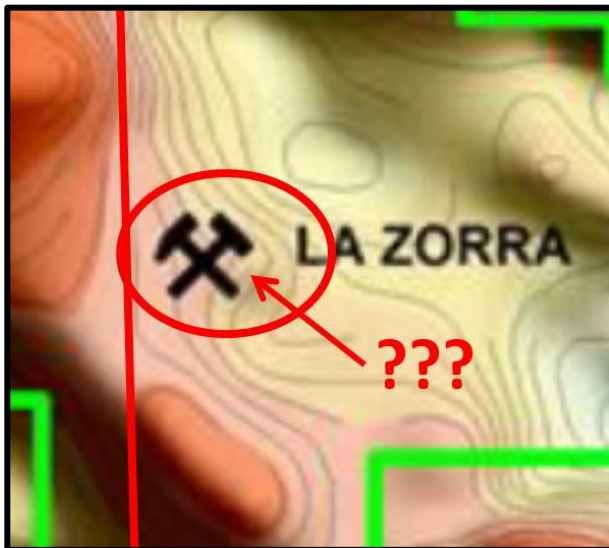
Figure 50. La Zorra Mine Magnetic Feature.

A slight 'bump' in the total magnetic field directly under the La Zorra mine could show the causative intrusive for the mineralization (Figure 50).

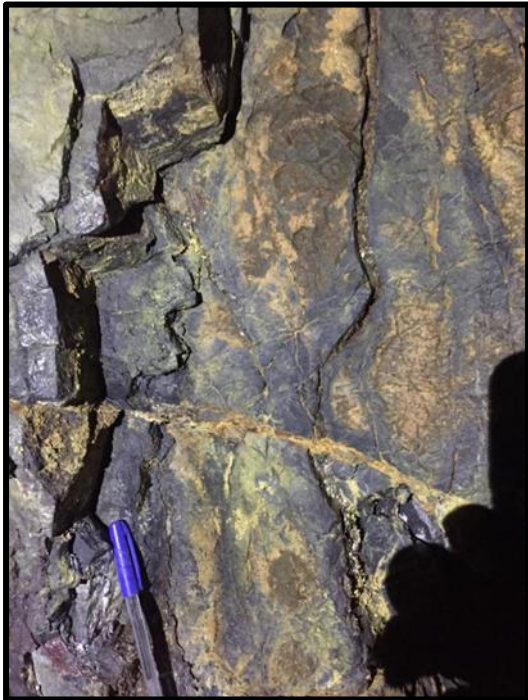
Figure 51. Sulfide Mineralization in Adit.

Four short adits at the El Moro mine penetrate a steep hillside and show splashy sulfide mineralization. (Figure 51). Initial sampling results were encouraging:

- Level 1. Au 0.64 ppm Ag 160 ppm
- Level 2. Au 3.21 ppm Ag 1552 ppm
- Level 3. Au 3.00 ppm Ag 1200 ppm
- Level 4. Au 3.82 ppm Ag 700 ppm

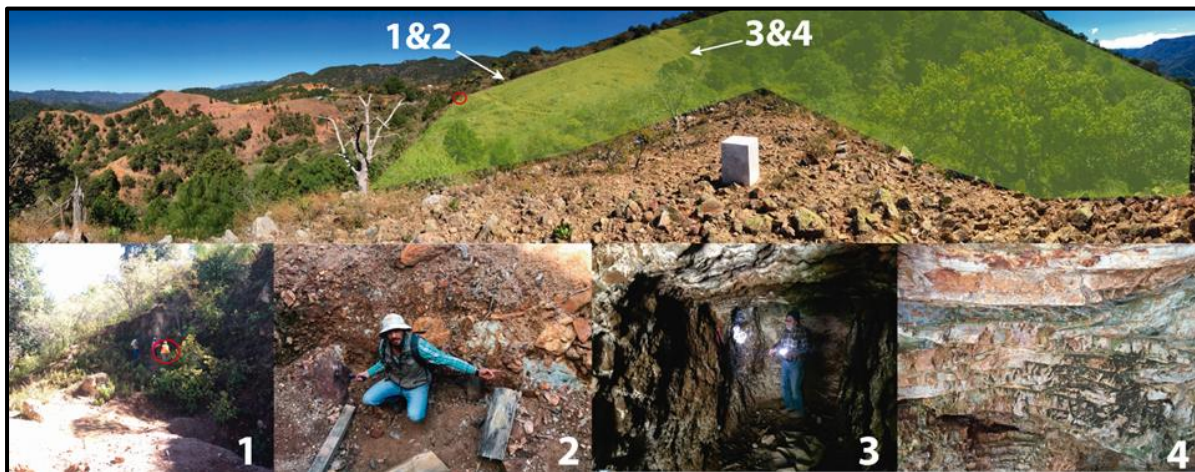
Figure 53. La Virginia Mine.

The mine has caved and there only is dump material and some exposures on the caved faces. Figure 53 shows a panorama with north workings in photos 1 and 2 and south workings in photos 3 and 4. A Diflor dump sample of a rhodocrosite vein assayed 1.14 ppm Au and 547 ppm Ag.

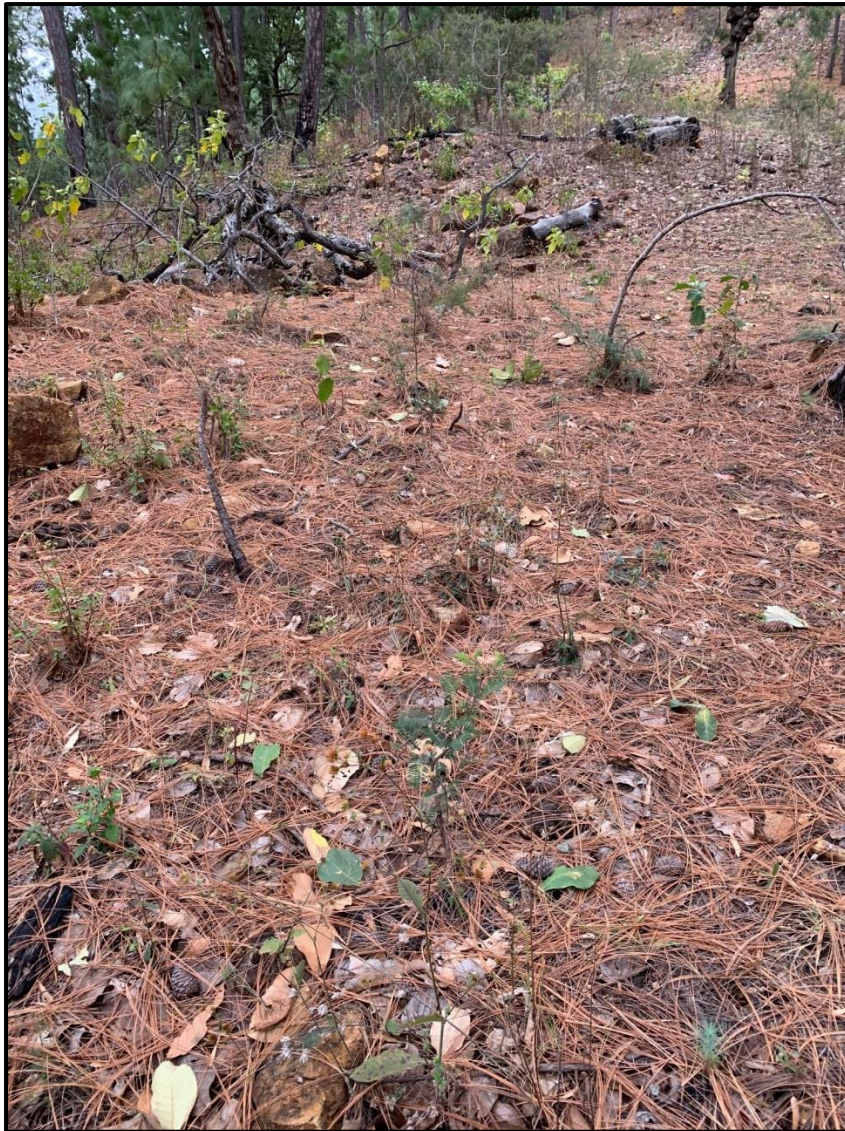
Figure 56. Soil and Plant Cover.

Also note in Figure 57 that the area is +90% covered by soil and vegetative material. Simple spot digging with a geology pick showed that cover is not thick and grid sampling with a shovel could be a very effective methodology.
